Cleaning Drain Lines on an ALPA Open Air Merchandiser

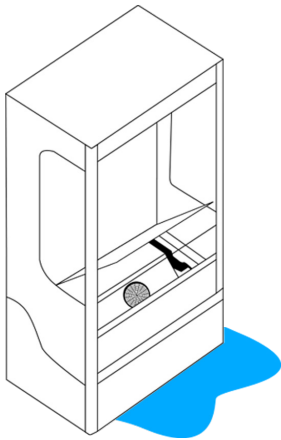
The drain lines can be accessed by removing the bottom panel from inside the unit.

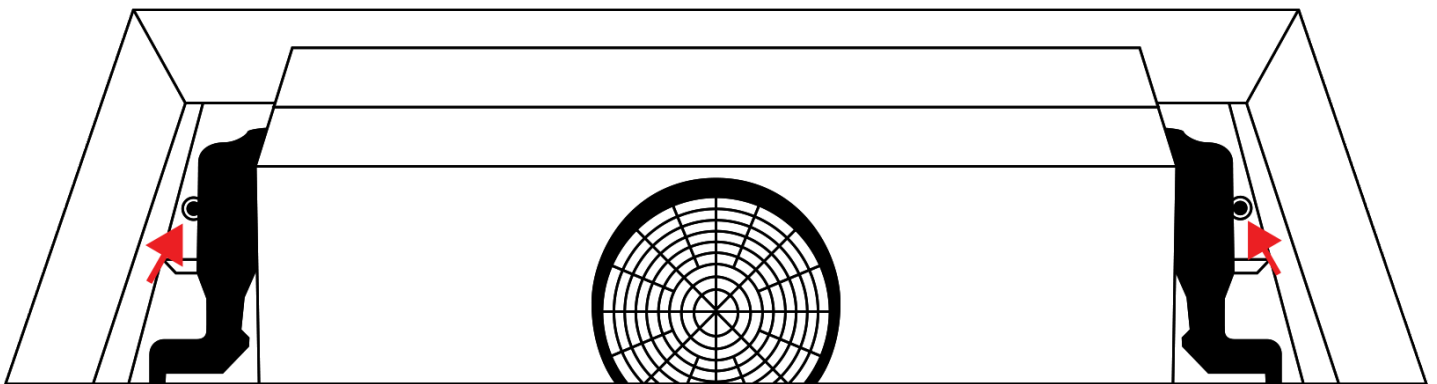
The drain lines can be accessed by removing the bottom panel from inside the unit. The drain lines are shown below.

Obstructions can be removed either by compressed air or nitrogen, or physically removing the obstruction with a drain cleaner. **DO NOT use a chemical drain cleaner, as this will void the warranty and possibly damage the unit.**
